Durability of Butyl fabrics in the Tropics

Technical Article: TA20

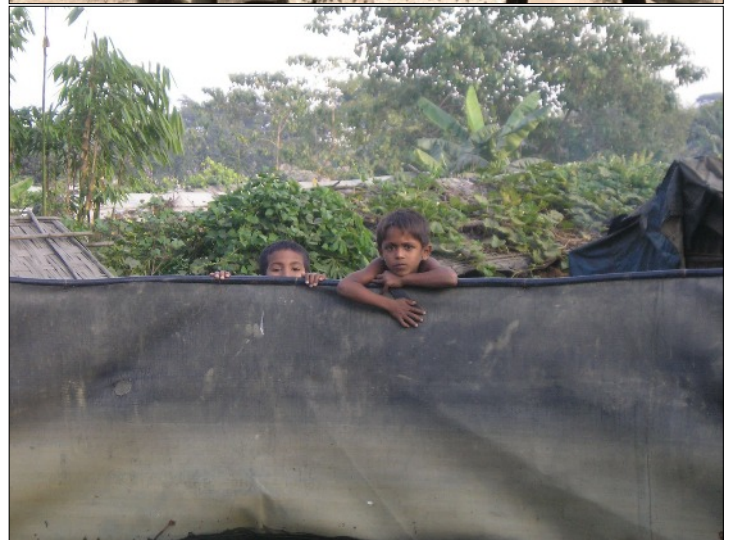
Bottom: Butyl lined water tank supplied to a Bangladesh refugee camp. Photo taken 13 years after installation.

One of the best examples of this track record can be found in the field of demountable water storage tanks. These products have been supplied by Butyl Products Ltd for many years. The lining of these tanks has been made from Butyl rubber, and in many instances they have been exposed and uncovered to the elements during their operational life. The photo below shows a water storage tank still in use 13 years after installation. As can be seen from the photo tank is still watertight and not showing any obvious degradation.

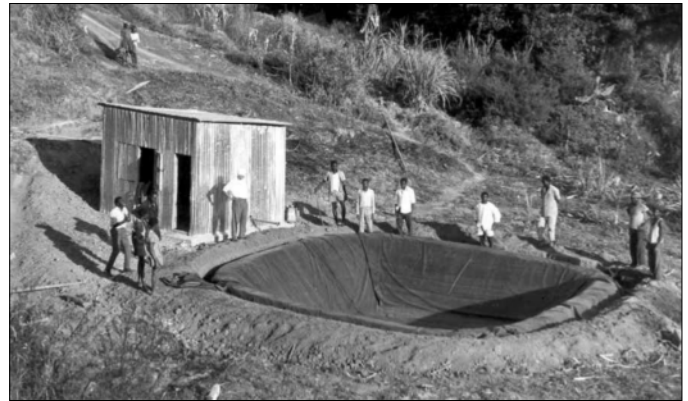
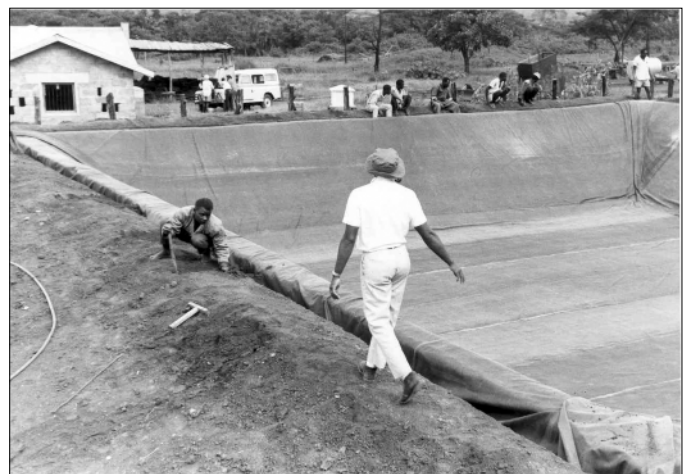
Top and middle right: Butyl lined sewage tank and water reservoir being built as part of aid activities

Butyl as a material has also been widely used for the purposes of lining reservoirs and large lagoons. The attached photos illustrate the material being used in these applications, and they would clearly not be appropriate, if they were to be vulnerable to chemical or ultraviolet degradation.

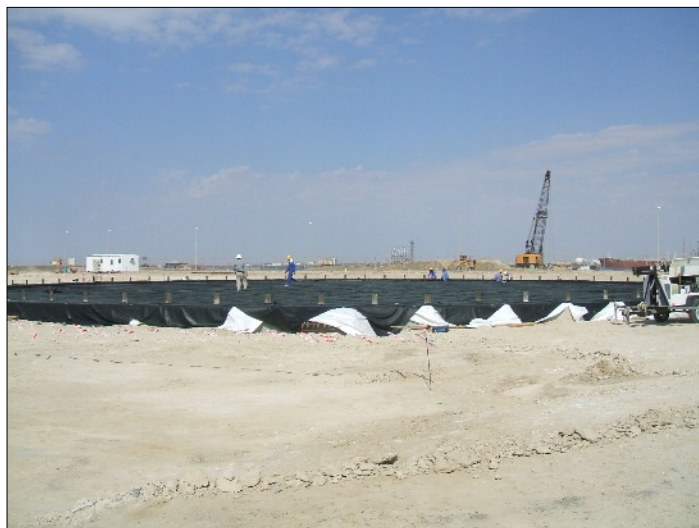
Bottom left: Butyl lined tank being built in Saudi Arabia (Whessoe) 2007

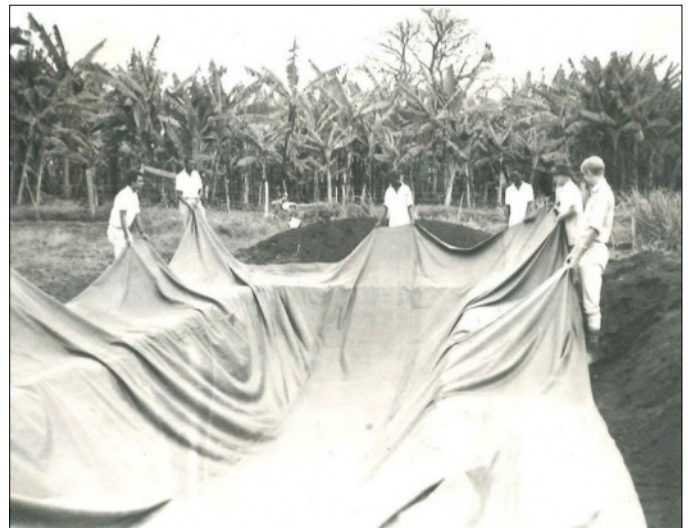
Bottom right: Irrigation pond liner being installed for sugar seedlings in 1967
